Brookdale – Brookhurst Facility

Access Compliance Evaluation Survey Barrier Report

Survey Date: June 19, 2019 / Report Date: August 5, 2021

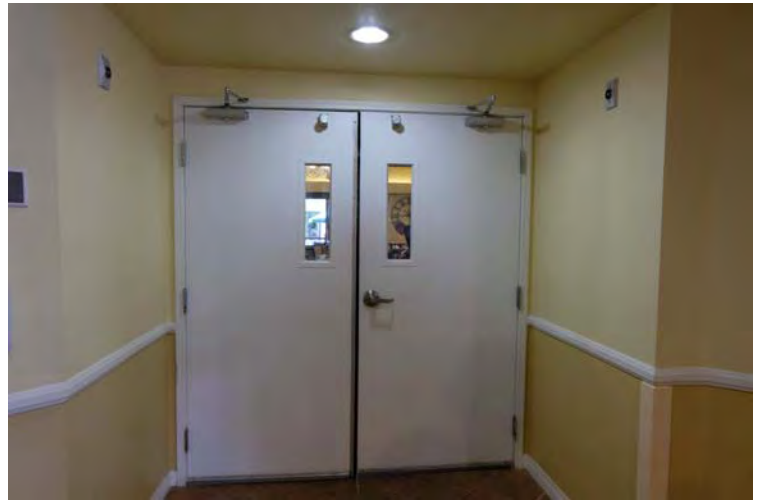
Brookhurst # 0002

29	Tactile Text and numerals at Permanent Identification Signage	Tactile characters are san-serif, and are neither italic, oblique, script, highly decorative, nor other unusual forms	11B-703.2.3	1117B.5.6.1	4.30.4	703.2.3	Barrier: Where tactile characters are provided at permanent identification signs, restroom wall signs and wall-mounted exit signs, they are of a text design that includes serifs. This item applies to all such signage at the facility. Barrier Removal: Remove and replace tactile signs Photos: 0002
----	---	---	-------------	-------------	--------	---------	---

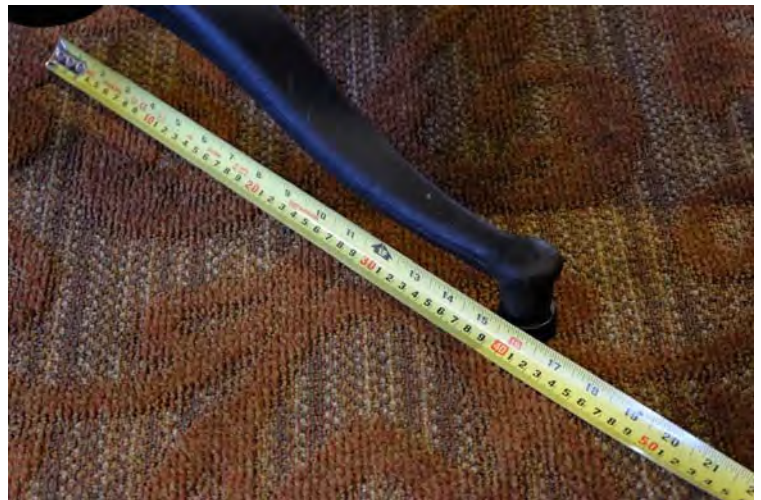
Brookhurst # 0016

30	Identification Signage - Location	Is the tactile sign provided to the right of the right hand door at double doors with two active leaves, or if no wall space is available, at the nearest adjacent wall?	11B-703.4.2	1117B.5.9	4.30.6	703.4.2	Barrier: Space is available at the right side of the right hand door, however the sign is placed at the left side of the left hand door. Barrier Removal: Relocate sign Photos: 0002 & 0003
31	Tactile Exit Sign - Provided	Is a tactile exit sign provided adjacent to the right side of the double door (viewed from the dining room side) and centered on an 18" x 18" clear floor space?	11B-216.4.1 & 1013.4	1117B.5.6.1	4.1.3. (16) (a)	216.4.1	Barrier: When an illuminated exit sign is required a tactile exit sign is also required. The required sign is not provided. Barrier Removal: Provide a tactile exit sign Photos: 0016

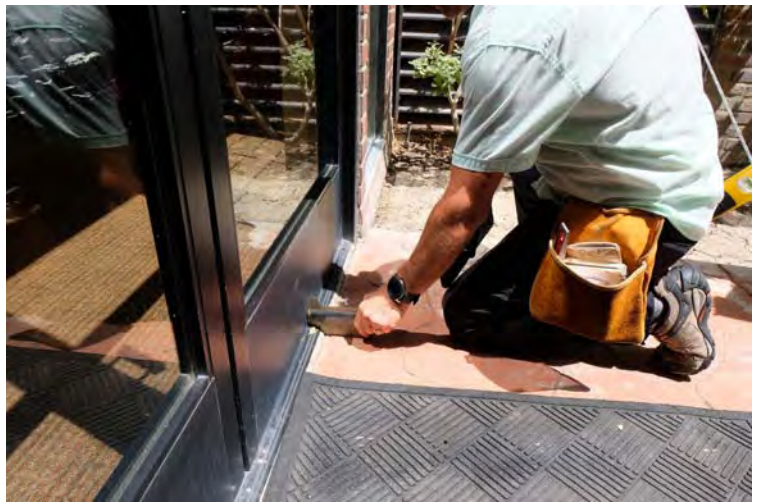
Brookhurst # 0126

42	Door Threshold	Is the threshold no higher than 1/2", and has a maximum vertical edge height of 1/4", and if higher than 1/4", the portion between 1/4" and 1/2" in height is beveled at 1:2 max.?	11B-404.2.5	1133B.2.4.1	4.13.8	404.2.5	Barrier: Overall threshold height is greater than 1" and is shaped as a 1:1 bevel Barrier Removal: Remove and replace threshold and exterior concrete door landing Photos: 0129 thru 0132
43	Accessible Reach Range – Forward Approach	Are the operable parts of elements accessed by forward approach no higher than 48" above the surface of the clear space?	11B-308.2.1	1118B.5	4.2.5	308.2.1	Barrier: The keypad operator is required to unlock the door. It is mounted to allow only forward approach and the highest buttons are 51-1/4" above the clear space surface Barrier Removal: Relocate keypad Photos: 0125 & 0126

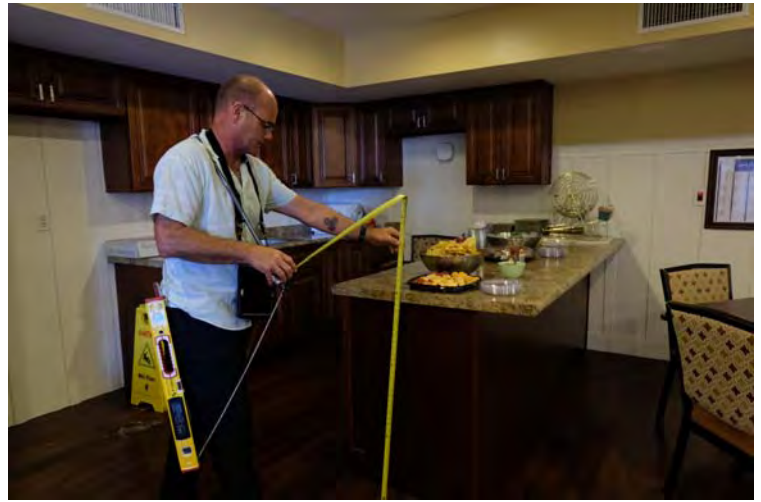
Brookhurst # 0170

56	Dining/Work Surfaces	At dining / work surfaces is the required knee space, 30" wide x 27" high x 19" deep, provided?	11B-902.4	1122B.3	4.32.2 & 4.2.4 & 28 CFR § 36.201 (a)	902.4 & 28 CFR § 36.201 (a)	Barrier: There are three non-fixed tables providing twelve total seats, requiring a min. of one accessible seating position. The knee and toe clearances at all tables is partially obstructed by table bases Barrier Removal: Remove and replace one table providing at least one accessible seating position Photos: 0170 & 0183

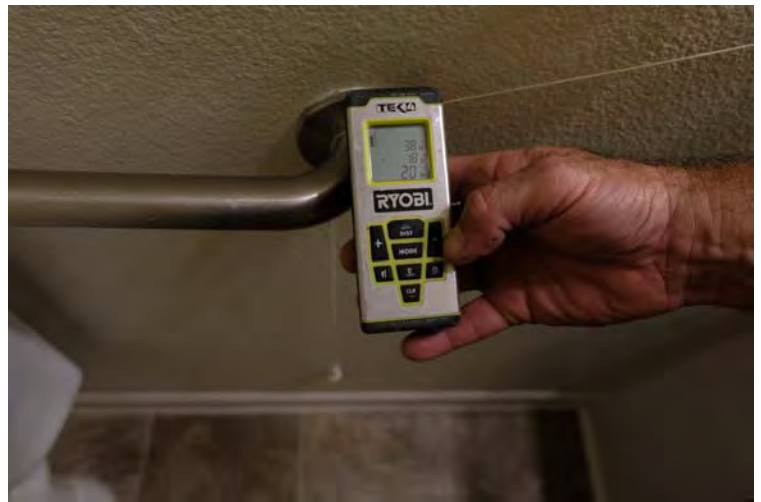
Brookhurst # 0249

95	Toilet – Location of flush Valve Control at Den Bathroom	Is the flush valve located on the wide side of the toilet area?	11B-604.6	1502.0	4.16.5	604.6	Barrier: The flush valve is located at the wall side of the toilet area rather than the wide side. Barrier Removal: Replace flush tank with one with the flush valve handle located at the wide side. Photos: 0239 & 0247
96	Toilet – Toilet Paper Dispenser Location at Den Bathroom	Is the centerline of the toilet paper dispenser located 7" to 9" from the front of the toilet to the centerline of the dispenser? (current standards) located within 12" from the front of the toilet? (1998 CBC) or the entire dispenser within 36" of the rear wall? (ADAAG).	11B-604.7.1	1115B.9.3 & Fig. 85	4.16.6 & Fig. 29(b)	604.7.1	Barrier: The location of this dispenser does not conform to any standard: The centerline of the dispenser is not 7" to 9" in front of the front of the toilet, nor within 12" of the front of the toilet, nor within 36" of the back wall. It is located more than 36" from the rear wall and 13.5" in front of the toilet. Barrier Removal: Relocate the surface mounted toilet paper dispenser Photos: 0239 & 0249

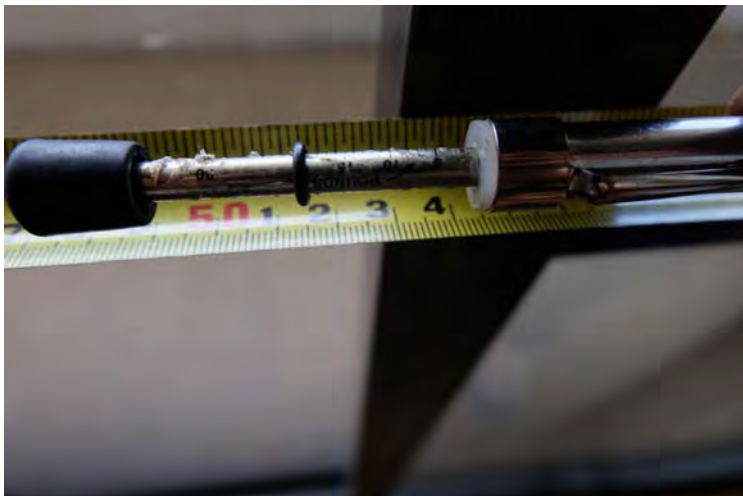
Brookhurst # 0264

109	Door – Opening Force at Bedroom Sliding Patio/Balcony Door	Is the force required to operate the sliding door no more than 5 lbs.?	11B-404.2.9.33 & 11B-108	1133B.2.5.1 & 1101B.3.1 & 2	4.13.11 & 28 CFR §36.211	404.2.9.9 & 28 CFR §36.211	Barrier: The force required to operate the door exceeds 5 lbs., measured at 11 lbs. in order to open the door to 21" clear, then 30 lbs. to fully open the door, apparently due to a damaged bottom track. Barrier Removal: Replace or repair door to bring within maximum opening pressure. Photos: 0264, 0265 & 0267

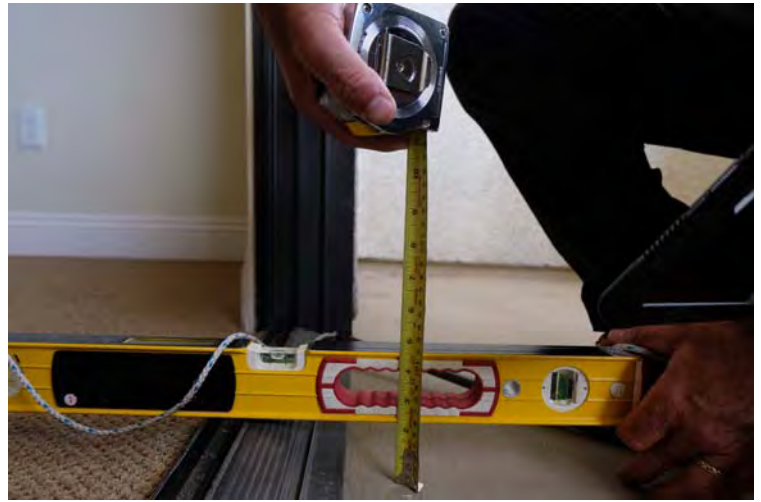
Brookhurst # 0287

Item	Element	Item Requirement	2019 CBC	1998 CBC & CPC	ADAAG	2010 ADA Standards	Barrier, Barrier Removal and Photos
88	Door – Clear Width at Living Room Sliding Balcony Door	Is the minimum clear width at the sliding door 32" minimum?	11B-404.2.3	1133B.2.2	4.13.5	404.2.3	Barrier: The clear width is less than 32", measured at 30.75" because a bumper prevents the door from opening fully. Barrier Removal: modify or replace bumper so that the door can open to the extent that it provides minimum 32" clear. Photos: 0284 thru 0286
89	Door – Threshold Height at Living Room Sliding Patio/Balcony Door	Is the threshold no more than ½" higher than the floor level at either side? (pertinent to 1998 and 2019 CBC and 2010 ADA) ¾" at exterior sliding doors? (pertinent to ADAAG).	11B-404.2.5	1133B.2.4.1	4.13.8	404.2.5	Barrier: The sliding door threshold track is higher than ¾", measured at 2.125" comprising vertical edges at each side. Barrier Removal: Remove and replace the sliding door and frame with one with a semi recessed bottom track, or alternately, replace the sliding door with a pair of swinging doors with a standard threshold. Photos: 0287 thru 0289

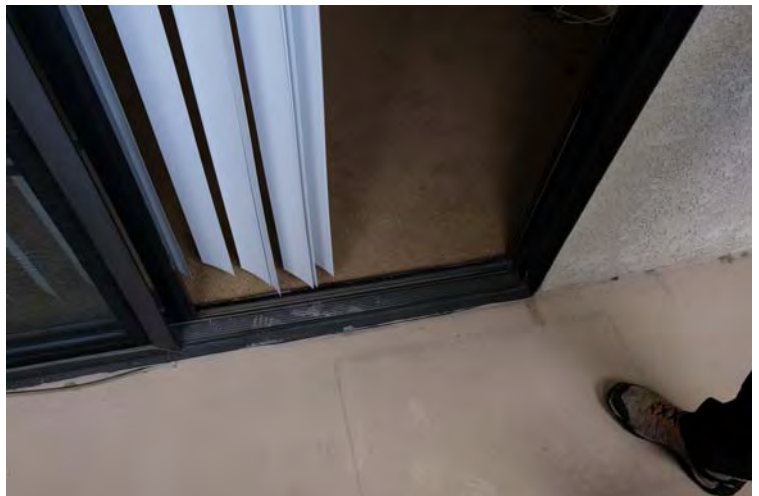
Brookhurst # 0319

113	Door – Clear Width at living Room Sliding Balcony Door	Is the minimum clear width at the sliding door 32" minimum?	11B-404.2.3	1133B.2.2	4.13.5	404.2.3	Barrier: The clear width is less than 32", measured at 30.75" because a bumper prevents the door from opening fully. Barrier Removal: modify or replace bumper so that the door can open to the extent that it provides minimum 32" clear. Photos: 0318
114	Door – Threshold Height at Living Room Sliding Patio/Balcony Door	Is the threshold no more than ½" higher than the floor level at either side? (1998 CBC and) ¾" at exterior sliding doors? ADAAG).	11B-404.2.5	1133B.2.4.1	4.13.8	404.2.5	Barrier: The sliding door threshold track is higher than ¾", measured at 2.125" comprising vertical edges at each side. Barrier Removal: Remove and replace the sliding door and frame with one with a semi recessed bottom track, or alternately, replace the sliding door with a pair of swinging doors with a standard threshold. Photos: 0319 & 0320

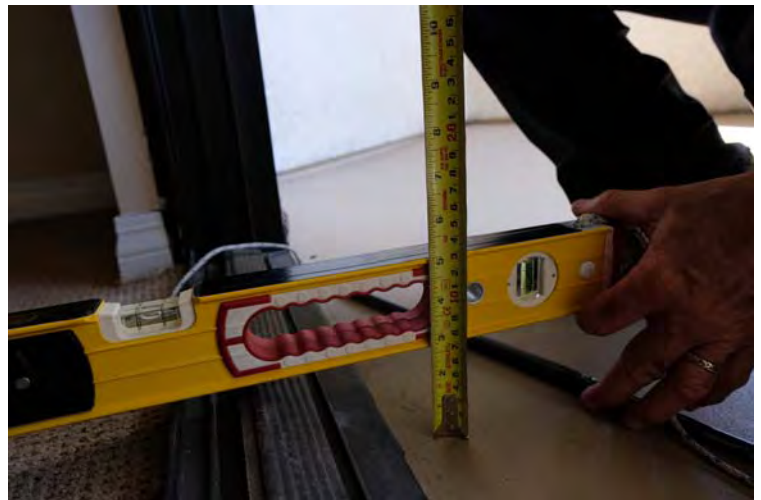
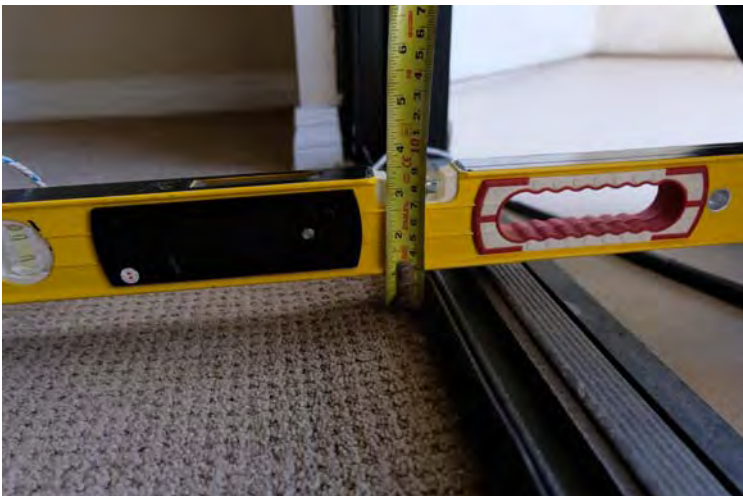
130	Door – Threshold Height at Living Room Sliding Patio/Balcony Door	Is the threshold no more than ½" higher than the floor level at either side? (1998 CBC) ¾" at exterior sliding doors? (ADAAG).	11B-404.2.5	1133B.2.4.1	4.13.8	404.2.5	Barrier: The sliding door threshold track is higher than ¾", measured at 2.75" comprising vertical edges at each side. Barrier Removal: Remove and replace the sliding door and frame with one with a semi recessed bottom track, or alternately, replace the sliding door with a pair of swinging doors with a standard threshold. Photos: 0372 thru 0374

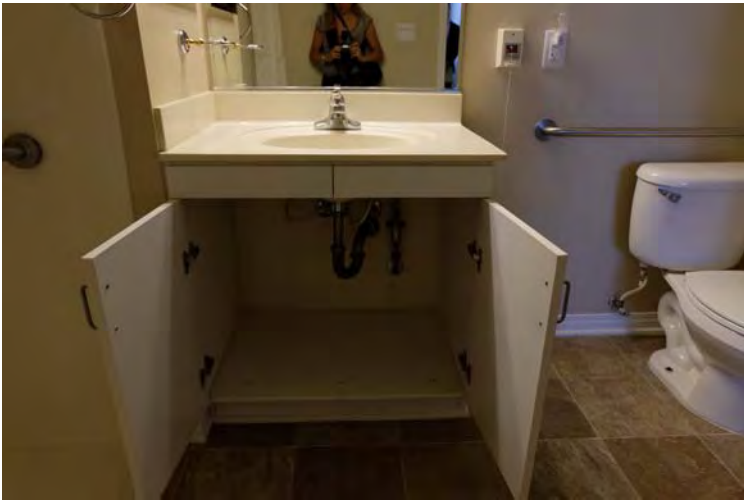
Brookhurst # 0386

138	Toilet – Height of Seat at Bathroom	Is the toilet seat 17" to 19" AFF?	11B-604.4	1502.0	4.16.3	604.4	Barrier: the toilet seat is lower than 17", measured at 15.25" AFF. Barrier Removal: replace toilet. Photos: 0386 & 0392
139	Grab Bar – Location of Side Bar	Does the side grab bar extend a minimum of 54" from the rear wall? (current CBC and ADA and ADAAG) extend a minimum of 24" in front of the toilet? (1998 and 2019 CBC). Does the side grab bar begin a maximum of 12" from the rear wall?	11B-604.5.1	1115B.8.1	4.17.6 & Fig. 29 & 30	604.5.1	Barrier: The Side grab bar begins farther than 12" from the rear wall, measured at 13.75". Barrier Removal: Relocate the grab bar. Photos: 0386 & 0394
140	Shower – Threshold at Den Bathroom	Is the entrance to the shower free of a raised threshold or curb? (ADAAG) threshold that is 1/2" maximum and beveled 1:1? (1998 CBC)	11B-608.7	1115B.6.2.2	4.21.7	608.7	Barrier: the shower threshold is 0.875" high when compressed under load. Barrier Removal: remove threshold Photos: 0402

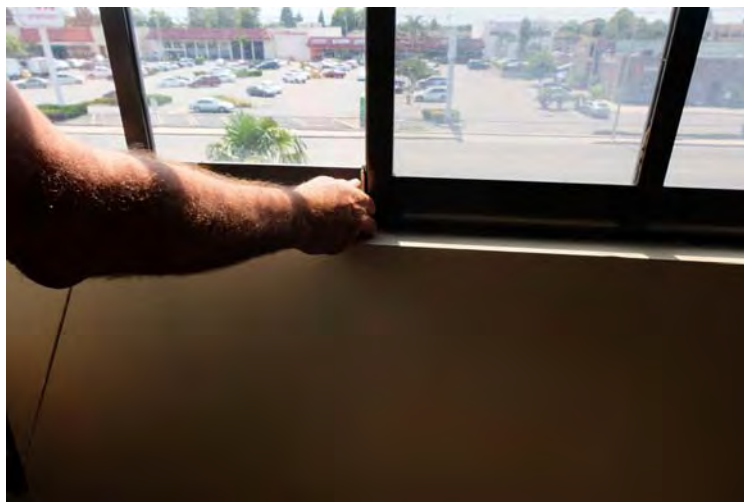
Brookhurst # 0507

Item	Element	Item Requirement	2019 CBC	1998 CBC & CPC	ADAAG	2010 ADA Standards	Barrier, Barrier Removal and Photos
175	Door – Hardware Use at Bedroom Entrance	Is the door hardware operable without requiring tight grasping, pinching, twisting of the wrist, more than one hand or greater than 5 pounds force?	11B-309.4	1117B.6.4	4.13.9	309.4	Barrier: the lock requires pinching and twisting of the wrist to operate. Barrier Removal: replace lockset. Photos: 0504
176	Controls - Height of Blinds Control at Bedroom Window	Is the control accessed by a parallel approach no higher than 54" AFF? (1998 CBC and ADAAG).	11B-308.2.1	1118B.5 & 6	4.2.5 & 6	308.2.1	Barrier: the window covering control is located higher than 54" AFF it is 60" AFF. Barrier Removal: provide longer wand(s) to extend down to within 48" of the floor level. Photos: 0507
177	Controls – Use of Bedroom Window Opening Hardware	Is the window hardware operable without requiring tight grasping, pinching, twisting of the wrist, more than one hand or greater than 5 pounds force?	11B-309.4	1117B.6.4	4.27.4	309.4	Barrier: the window lock requires pinching and twisting of the wrist to operate. Barrier Removal: provide accessible lock. Photos: 0507 thru 0509

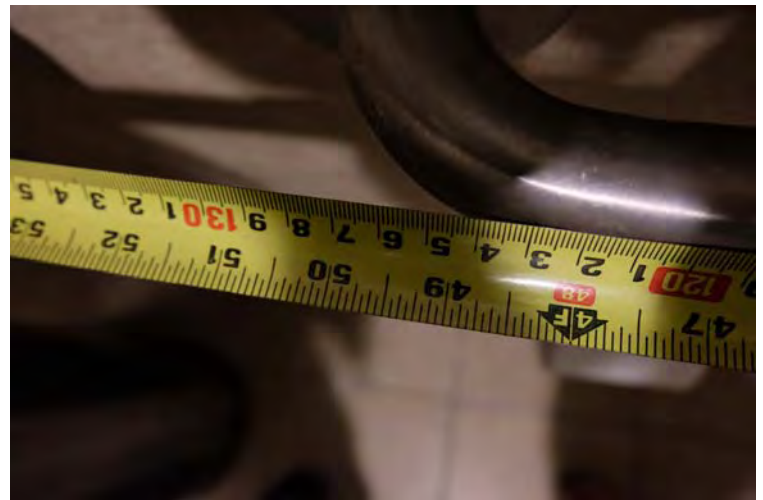
Brookhurst # 0597

81	Toilet - Location of Flush Valve	Is the flush valve located at the wide (i.e., open) side of the toilet area?	11B-604.6	1502.0	4.16.5	604.6	Barrier: The flush valve is located at the wall side of the toilet area rather than the wide side. Barrier Removal: Replace flush tank with one with the flush valve handle located at the wide side. Photos: 0593
82	Grab Bar - Height	Are grab bars located: at at 33" AFF to centerline? (1998 CBC requirement) and 33" to 36" AFF to centerline? (ADAAG requirement)	11B-609.4	1115B.8.1	4.17.6 & Fig. 29 & 30	609.4	Barrier: The height of the side grab bar is 31.5" to top of gripping surface (31" to centerline). Barrier Removal: Relocate the grab bar to conform to current CBC and ADA standards. Photos: 0591 & 0597

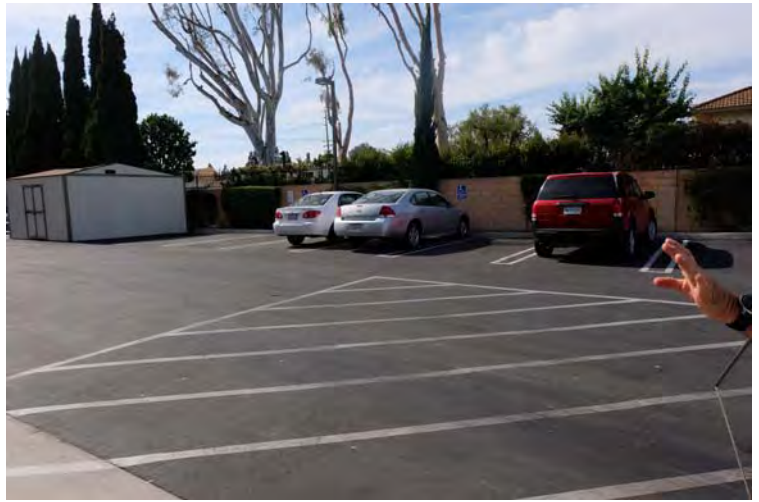
Brookhurst # 0771

21	Access Aisle	Is an access aisle provided adjacent to the accessible parking space?	11B-502.2	1129B.4.1	4.6.3	502.2	Barrier: No access aisle is provided. The areas to each side of the parking space are other parking spaces Barrier Removal: Provide adjacent access aisle by applying surface markings and relocating parking as necessary Photos: 0768, 0769 & 0771
22	Parking Space Width	Is the parking space at least 108 inches (9'-0") wide?	11B-502.2	1129B.4.1	4.6.3	502.2	Barrier: The space is 90" wide (7'-6"). Barrier Removal: Blackout surface striping and re-stripe Photos: 0750, 0751, 0752
23	Surface Markings – ISA Symbol	Is the parking space marked with a min. 36" by 36" ISA in white on a blue background, centered within 6" of the width of the parking space and located at the rear of the space?	11B-502.6.4	1129B.51&2	N/A	N/A	Barrier: None provided Barrier Removal: Provide surface painted ISA Photos: 0771

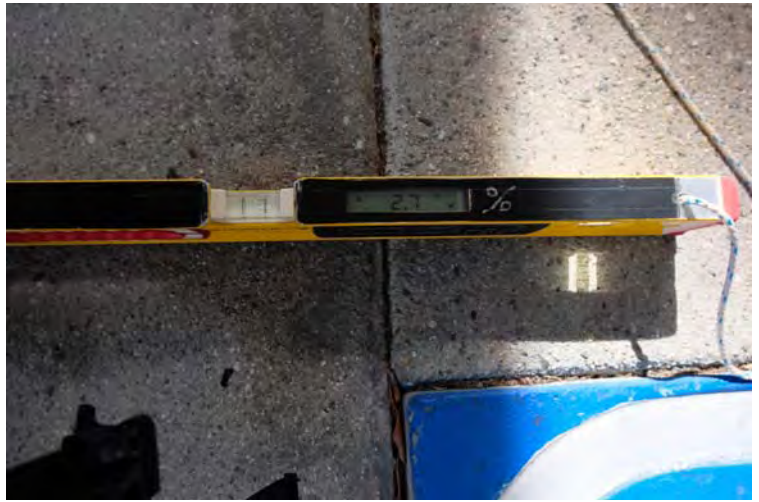
Brookhurst # 0801

2	Surface characteristics	Is the surface of the parking stall stable, firm and slip resistant, free of gaps exceeding 1/2" in width, and free of changes in level, except for slopes not exceeding 1:48 (≈2.1%)?	11B-502.4	1129B.4.4	4.6.3	502.4	Barrier: The white portions of the pavement ISA symbol and border are stamped into the surface of the concrete at both parking stalls, creating multiple level changes of 1/8" or more. In addition, The surface slopes along the tail end of the parking stalls and access aisle measure 2.7% Barrier Removal: Remove and replace the concrete ISA symbols and the concrete along the rear of the parking stalls and access aisle. Photos: 0792 thru 0803
